## ENGINEERING GEOLOGICAL ASSESSMENT AND GROUND BEHAVIOR OF TECTONICALLY DISTURBED ROCKS IN NORTHERN THAILAND. A CASE STUDY OF THE PHAYAO RAILWAY TUNNELS

**Abstract:** This paper presents a geotechnical analysis of the southern Phayao Tunnels (T3), which are part of the Denchai-Chiang Rai-Chiang Khong Railway Construction Project (Contract 2, Ngao-Chiang Rai section) in the Lampang-Phrae Basin, Thailand. The geological and geotechnical challenges during tunnel construction are highlighted, focusing on analyzing rock mass behavior and events during tunnel excavation. The research has integrated data from three sources, including borehole investigation data, seismic refraction survey data, and actual field observations, to provide a comprehensive overview of the project area's geological conditions for assessing the rock mass's geotechnical properties. In evaluating rock mass properties, the study applied the Rock Mass Rating (RMR) system and Geological Strength Index (GSI), which helped efficiently classify and predict rock mass behavior in the tunnel area. Additionally, the study monitored and analyzed tunnel movements (convergence monitoring) to assess structural stability. Incid

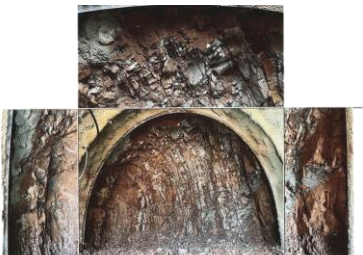
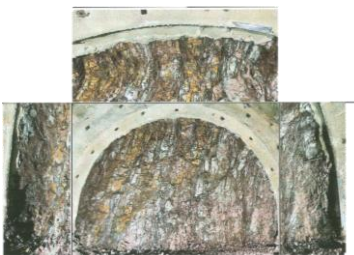
STA 663+329.916	STA 663+600.116	STA 663+725.116

Siltstone brown to reddish brown, slightly to moderately weathered, medium to thick bed. The strength form field estimation is 25-50 MPa.	Siltstone interacted with laminated sandstone, brown to reddish brown, moderately to highly weathered, medium to thick bed. Highly sheared rock mass of low strength, the strength form field estimation is 5-25 MPa.	Siltstone interacted with laminated sandstone, brown to reddish brown, highly weathered, thin bed. Highly sheared rock mass of low strength is present filled with clay along the joint and bedding planes. Tectonically disturbed sheared siltstone with broken deformed sandstone layers. almost a chaotic structure
STA 663+775.278	STA 663+818.278	STA 663+826.116

Table 1 Shows geological information that appear on the face along the Phayao tunnel excavation route.

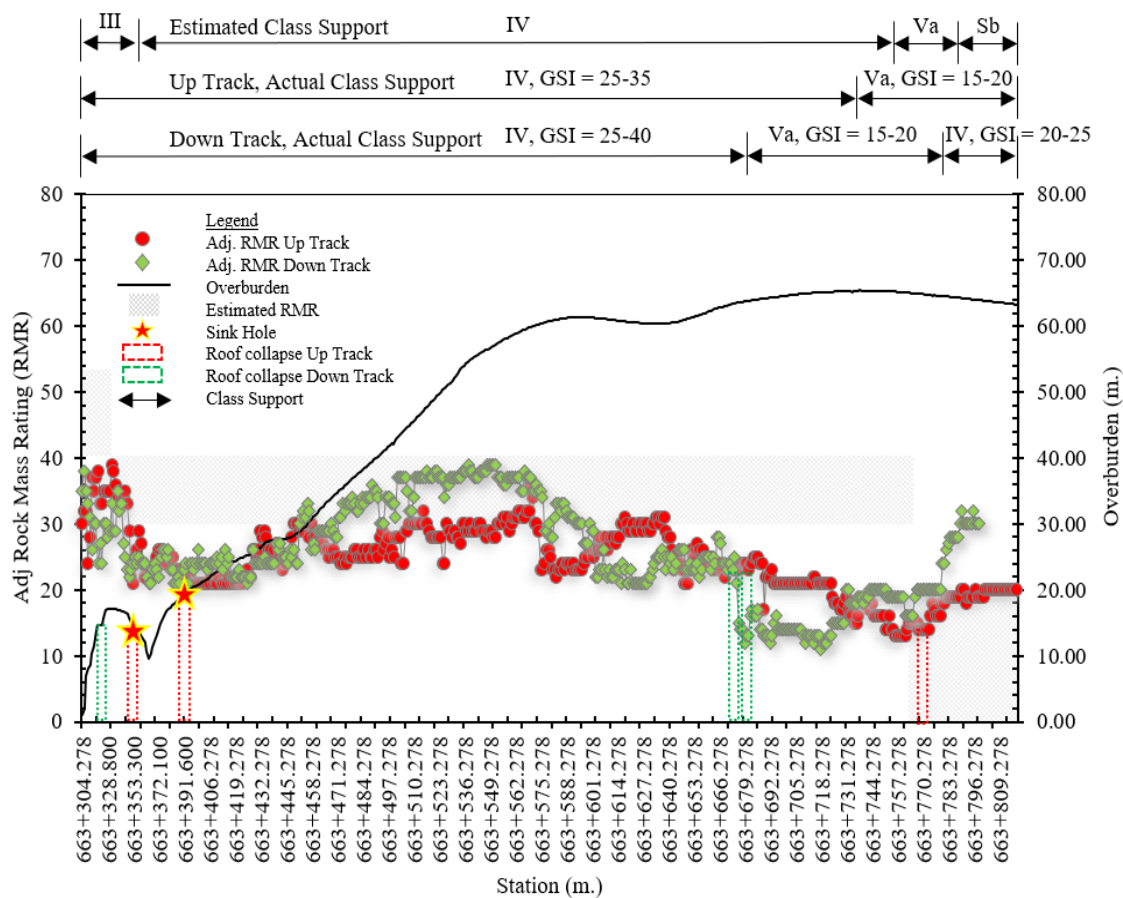
**Figure 4.** Shows the analysis of the evolution of the Rock Mass Rating (RMR) system in the Phayao tunnel.

As shown in Fig. 4, geotechnical data analysis along the entire 500-meter Phayao Tunnel excavated in rock (from south portal) reveals a clear relationship between RMR, GSI values, and geological conditions. The tunnel was excavated through two major rock units characterized by numerous joints, faults, high groundwater infiltration, and highly weathered rock. In these geologically complex areas, RMR and GSI values have significantly decreased. This decrease correlates with seven tunnel roof collapses, particularly at the interfaces between rock units. Rock mass quality fluctuates most dramatically in fault zones, while overburden layer thickness increases progressively along the drilling distance of both up-track and down-track tunnels. This study's

results indicate that changes in geotechnical index values can serve as important indicators for predicting areas at risk of tunnel instability. Areas with extensive faulting and highly weathered rock require special pre-support measures to maintain stability.

The analysis of the evolution of the Rock Mass Rating (RMR) system in the Phayao Tunnel found that the estimated and actual values of the rock mass rating were significantly different, especially in the groups of rock classes III, IV and V. The estimated tunnelling length of class III was 10.31%, but it was not found in the actual excavation. The actual tunnelling length of class V was much higher than the estimation, from 5.15% to 18-21%, indicating that the rock in the area was in a worse condition than expected, resulting in the need for additional support measures. The average actual excavation rate was 0.82 m/day, with several roof collapses, resulting in delays and the need to adjust the stabilization method during tunnel excavation.

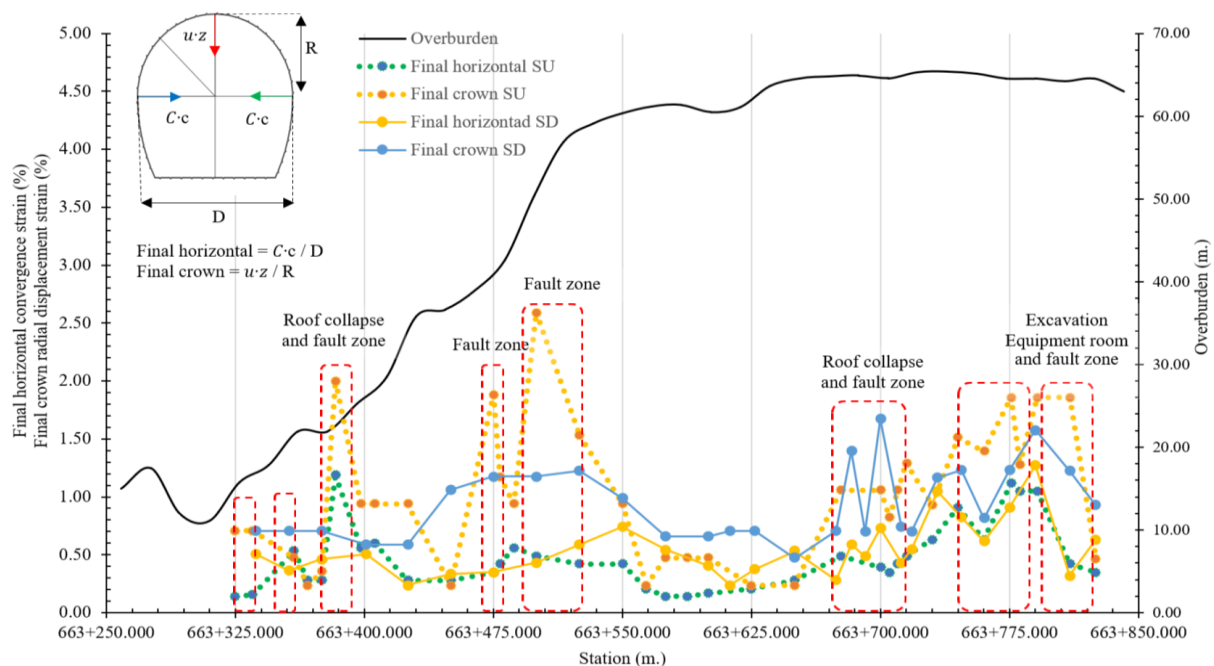
**Figure 6.** Final convergence and crown radial displacement at 63 section monitoring cross-sections in the Phayao tunnel (including Up track and Down track tunnel)

As shown in Fig. 6, analysis of tunnel wall deformation in rock from station 663+250 to 663+850 meters, under 15-65 meters of overburden, demonstrates the relationship between horizontal and crown convergence strain at 63 monitoring sections. Critical points with roof collapse and fault zones were identified at seven locations showing abnormally high deformation (1.0-1.5%), particularly at station 663+500, and in the 663+700 to 663+800 region displaying irregular movement near the excavation of equipment room which are directly affected by changes in the contact of unconsolidated sediments and rock geology. The differences between up-track and down-track

tunnel values reflect asymmetric deformation due to rock mass heterogeneity. In contrast, the low deformation values at stations 663+500 to 663+625 indicate improved rock mass quality. The crown-to-horizontal convergence ratio provides insights into joint orientation within the rock mass. This data is very important for tunnel engineers to consider and decide on the appropriate excavation method, with high-convergence-strain areas requiring additional reinforcement to enhance tunnel construction safety.

Analysis of convergence monitoring at STA 663+500 (Monitoring section U8) reveals asymmetric deformation behavior, with maximum crown settlement reaching 110 mm, significantly exceeding the horizontal convergence. This reflects the influence of high vertical stress and the presence of horizontal joints in the rock mass. Time-displacement experienced the greatest settlement of 110 mm within 80 days, with high deformation rates during the first 40 days gradually decreasing until stabilization after 60-70 days. Meanwhile, horizontal displacement demonstrates inward movement toward the tunnel axis from both sides. This behavior corresponds to time-dependent deformation and ground reaction curve theories in low-quality rock mass near the fault zone. Additional reinforcement measures should be considered, such as increasing shotcrete thickness, installing longer rock bolts, or implementing steel ribs in this area to control deformation within acceptable limits and prevent long-term tunnel collapse.

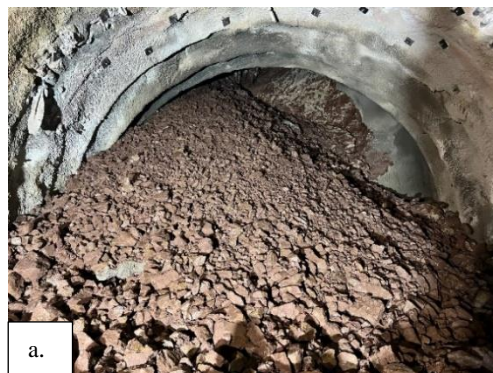
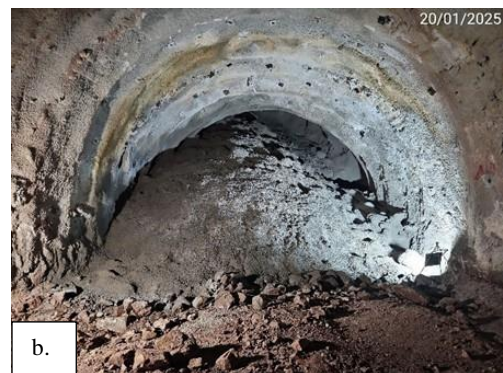
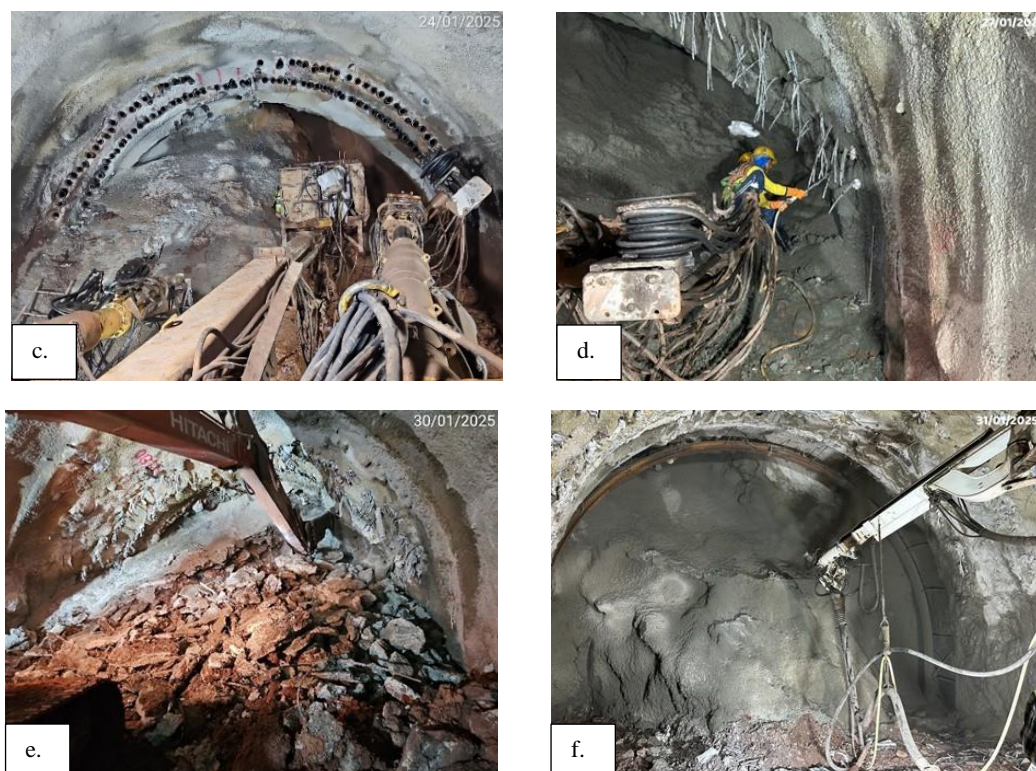
**Figure 7.** Show the incident roof collapse at STA 0+770.278 (Up track)

- a.) Geological characteristics after the collapse of the tunnel.
- b.) Starting to spray flashcrete to cover the pile of rocks.
- c.) Install the pre-support of pipe roof.
- d.) Inject cement water through the pipe roof.
- e.) Remove the fallen material and continue excavating.
- f.) Install the steel rib and proceed to the normal tunneling process.

During the excavation of the southern Phayao Tunnel, along the total distance of both tunnels (up and down tunnel), approximately 1,000 meters, there were seven incidents of tunnel roof collapses. Table 2 lists the collapse patterns and relevant geotechnical and geological parameters. Most tunnel collapse events showed rock mass behavior with a tendency to shear and raveling failure. For example, 1 in 7 incidents at STA 0+770.278 at the up-track tunnel was excavated using the mechanical method. This section encounters extremely challenging geotechnical conditions with severely damaged rock formations and strengths below 1 MPa, having been extensively damaged by tectonic disturbance. The geological profile featured collapse-prone structures with multiple shear zones, faults, and structurally deficient rock formations. The extremely low rock mass rating (RMR) of less than 20 classified the area as very poor rock with critical stability durations of only 24-54 minutes before collapse. The engineering assessment confirms that these severe instability factors, particularly the tectonically compromised structure and extremely brief standup time, were the direct causes of the roof failures experienced during tunneling operations. After the incident, as shown in Fig. 7, the correction was done by spraying flashcrete to cover the pile of rocks that fell in the tunnel. Install the pre-support of pipe roof in sufficient quantity according to the geological conditions. Then, inject cement water through the pipe roof according to the amount specified and wait for the cement to set according to the specified time. Then remove the fallen material and continue

excavating according to the standard tunneling procedure. The work site has made corrections according to the operating procedures, which took 12 days to fix.
